Manhole Inspection Summary

Manhole # S19KK_051MH

Insp Date: **6/5/07 10:10 AM**

Location Address: **2023 PILASKI-PAYSON**

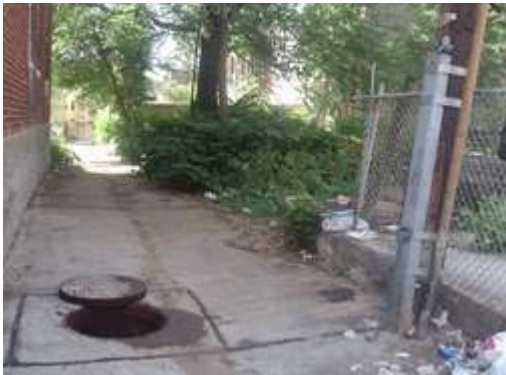
Location View

DEBRIS

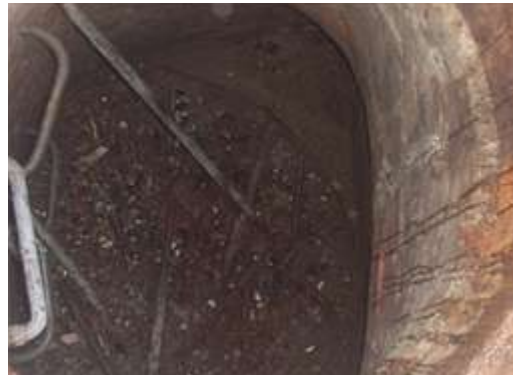
Top View

DEBRIS

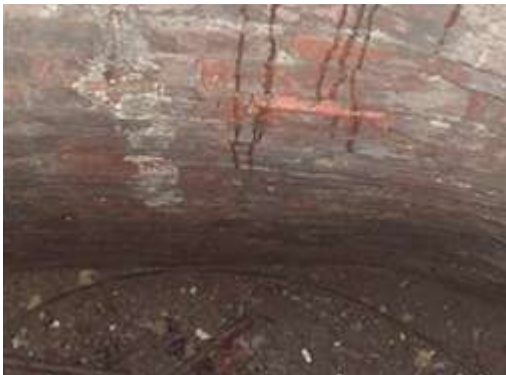
Defect 2

Condition: ☐ Sound ☐ Cracked ☐ Root Intrusion ☒ **Loose Brick** ☐ Deteriorated

LOOSE CORBEL BRICK

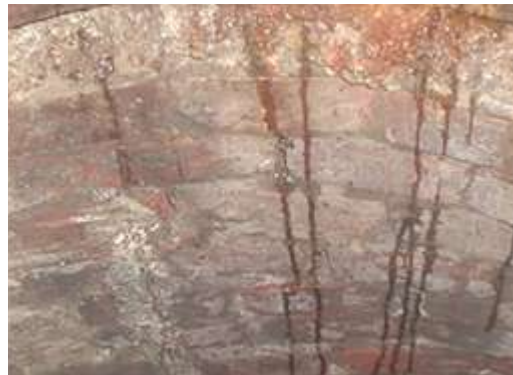
Defect 1

Condition: ☐ Sound ☐ Cracked ☐ Root Intrusion ☐ Loose Brick ☒ **Deteriorated**

Infiltration: ☐ None ☐ Joint ☐ Cracks ☐ Mortar ☐ Roots ☒ **Wall**

INFILTRATION OF CHIMNEY AND
DETERIORATION

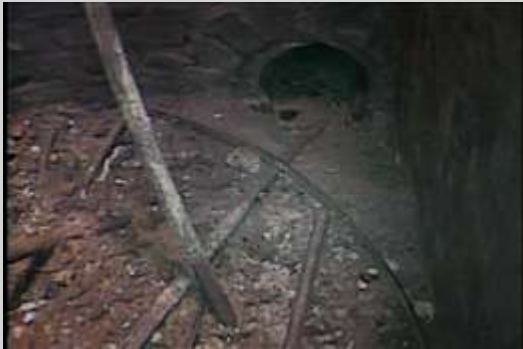
12 O'Clock Outflow

8 in. Circular Gravity Sewer
Pipe Out @ 12 O'Clock

Deposits: ☐ None ☐ Mud ☐ Sludge ☒ **Debris** ☐ Grease

Silt Depth: **3** (in.) Deposits Extent: **Medium**
